Customer Name: Malaysia Productivity Corporation (MPC)	Date: 11th August 2022
Project Name: CCTV System Troubleshooting	Location: Malaysia Productivity Corporation 894, Lorong Demak Laut 3a, Demak Laut Industrial Park, 93050 Kuching, Sarawak
Description of Troubleshooting: <ol style="list-style-type: none"> <u>CCTV Camera</u> Because there is no power, the status of the CCTV camera is unknown. The CCTV camera, on the other hand, operates on analogue signals and RG59 coaxial cable. Both the camera model and the cabling are out of date. Replacing the camera with a newer analogue camera may cause compatibility problems with the existing cabling and digital video recorder (DVR). <u>Digital Video Recorder (DVR)</u> The DVR is in the manager's room. Both the DVR and the power supply unit (PSU) are powerless. There are burn marks on the main power cable that connects to the PSU unit. We did not perform any additional tests on the PSU unit due to the burn mark and safety concerns.

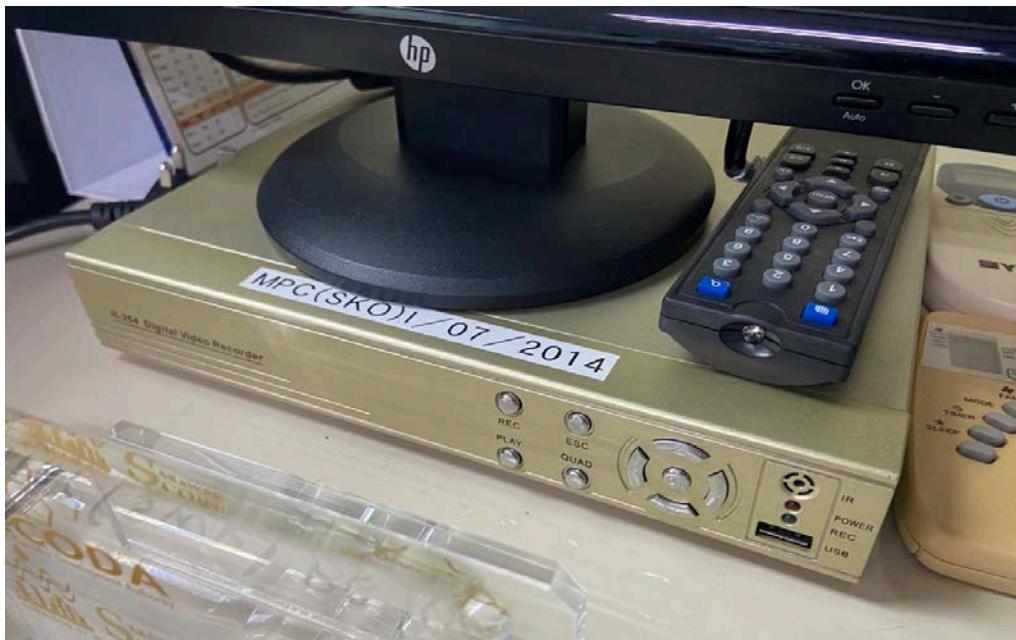
The existing DVR (8-channel DVR with H.264 compression)

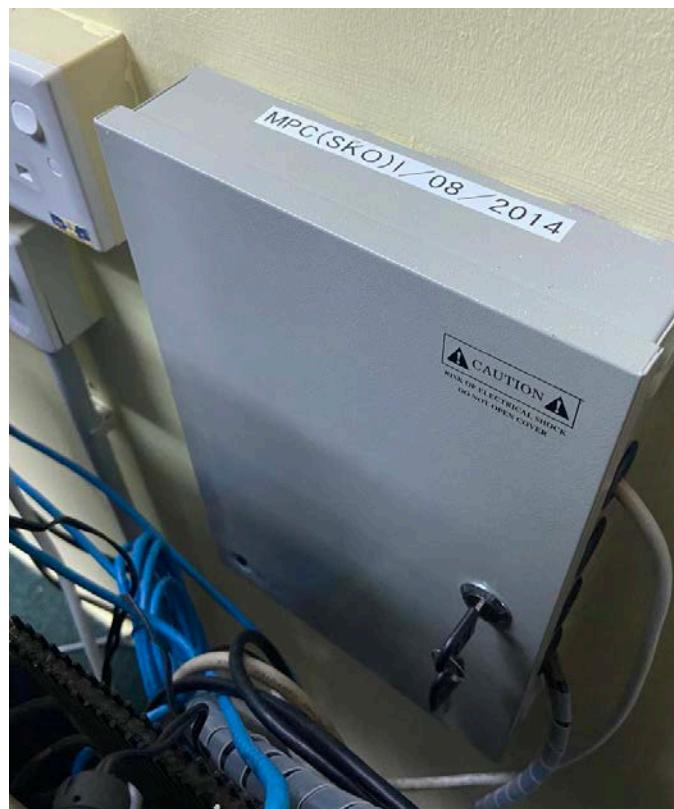
The PSU unit (16-channel power with metal casing)

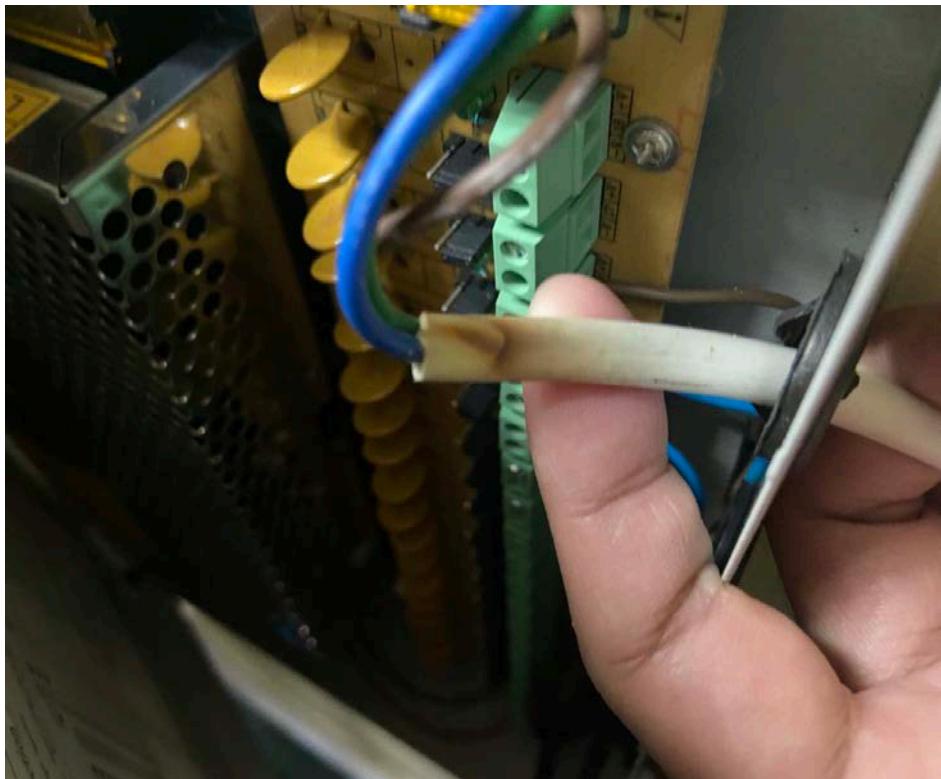
Photo of the burn mark at PSU main cable

Suggested Solutions <ol style="list-style-type: none"> Replace the entire camera as well as the cabling. Although a new analogue camera may be compatible with existing RG59 cable, the length of the cable will degrade video quality because RG59 has a maximum length of 100 feet (30 meters). Newer RG6 coaxial cable (Analog camera) can run at 305 meters, while Category 5 extended network cable (Cat.5e for IP camera) can run at 250 meters without losing signal or degrading video quality. Replace both the DVR and the power supply unit. Because there are signs of burn inside, the power supply is already faulty and could cause harm if used further. Maintaining the DVR may cause compatibility issues with new cameras and result in low video quality. 	
Prepared by:

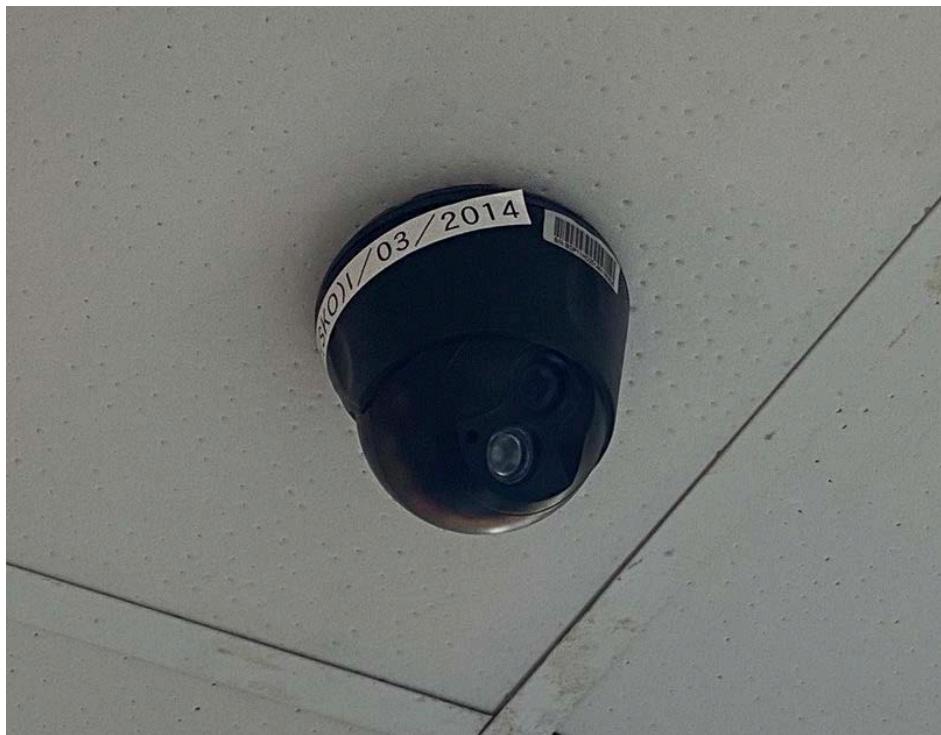
One of the existing Dome Camera (Analog camera)
